**INCIDENT NUMBER: 12-E-CBX**

**COUNTY: Kittitas**

**STATE OF WASHINGTON  
DEPARTMENT OF NATURAL RESOURCES  
Southeast Region  
WILDLAND FIRE INVESTIGATION REPORT**

**FIRE NAME:** Taylor Bridge Fire

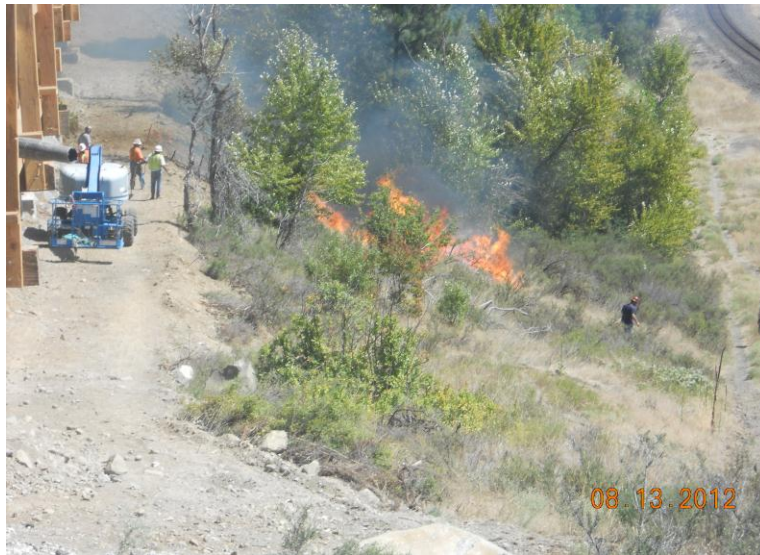
*(Picture003.jpg taken by Otero)*

Otero stated at approximately 1330 hrs. he heard someone shout “fire” on the job site. He was on Highway 10 on the west end of the bridge’s job site and looked to the east below the bridge. He said he observed a fire burning in the grass and brush below the bridge. He photographed it as it progressed. However, it should be noted he actually called 911 at approximately 1319 hrs. to report the fire and first observed the fire approximately 5 minutes prior to reporting it (approximately 1314 hrs.). He stated the fire was approximately 15 feet in diameter when he called the fire department. See Otero’s written statement and copies of the photos he took of the fire. (See attachment G1-KITTCOM CAD Log and attachment E6 Otero Statement).
